Cathodic Protection Case Study: Parker Dam Spillway Gates

Parker Dam Spillway Gate CP

Cathodic Protection Case Study: Mni Wiconi Core Pipeline

Mni Wiconi Core Pipeline - CP

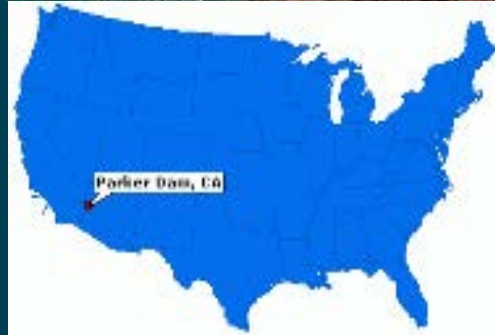
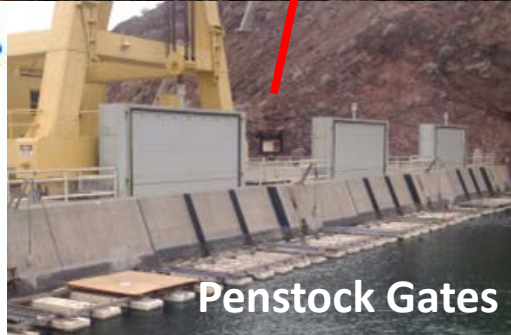
- Parker Dam, CA (1938)
 - Colorado River, Lake Havasu
 - “Deepest dam in the world”
 - Powerplant- four units: 30,000 kW each

- Coated structures and equipment – receiving the most severe exposures
 - Spillway Gates (5), Penstock Roller Gates (4), Penstock (4)
 - Scroll Case, Turbine Runner, Draft Tube, Etc. (4)
 - Trash Rack panels

- Cathodic protection
 - Penstock Gates – GACP (Complete)
 - Spillway Gates – ICCP (In Progress)

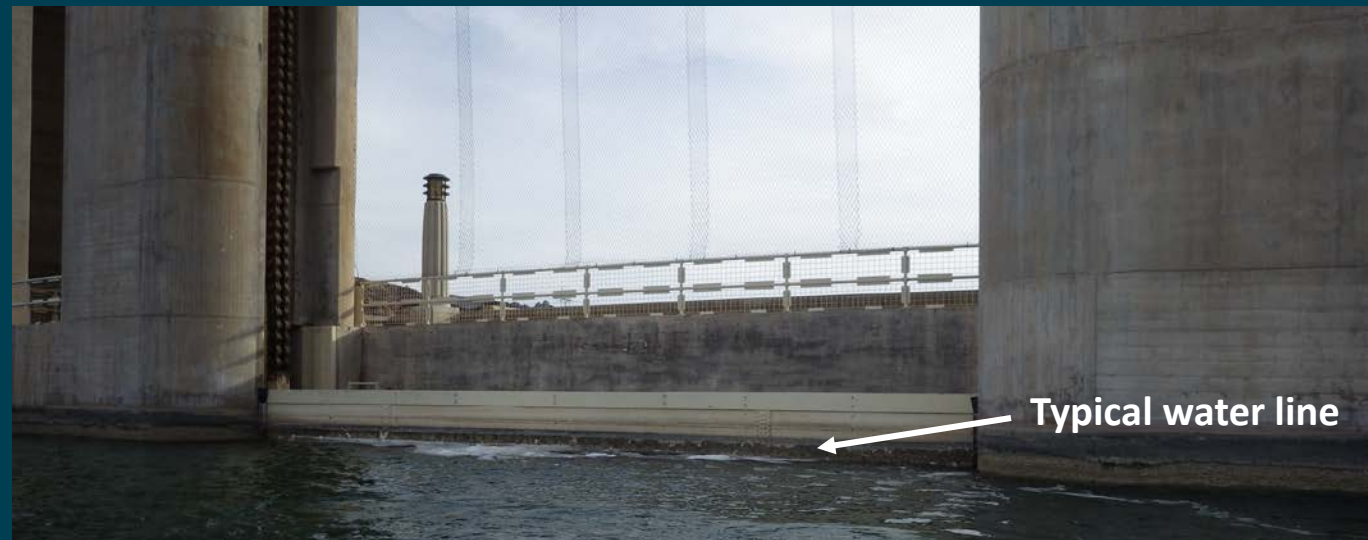
Parker Dam Spillway Gates

Design Data:

- Gate Size: 50 ft x 50 ft
- Riveted Construction
- Slide Gate Style (Stoney)
- Water line ~3-5 ft from top of gate
- Mudline ~ 2 ft from bottom of gate
- Water Specific Conductance (2008-2010)= 1000 $\mu\text{S}/\text{cm}$

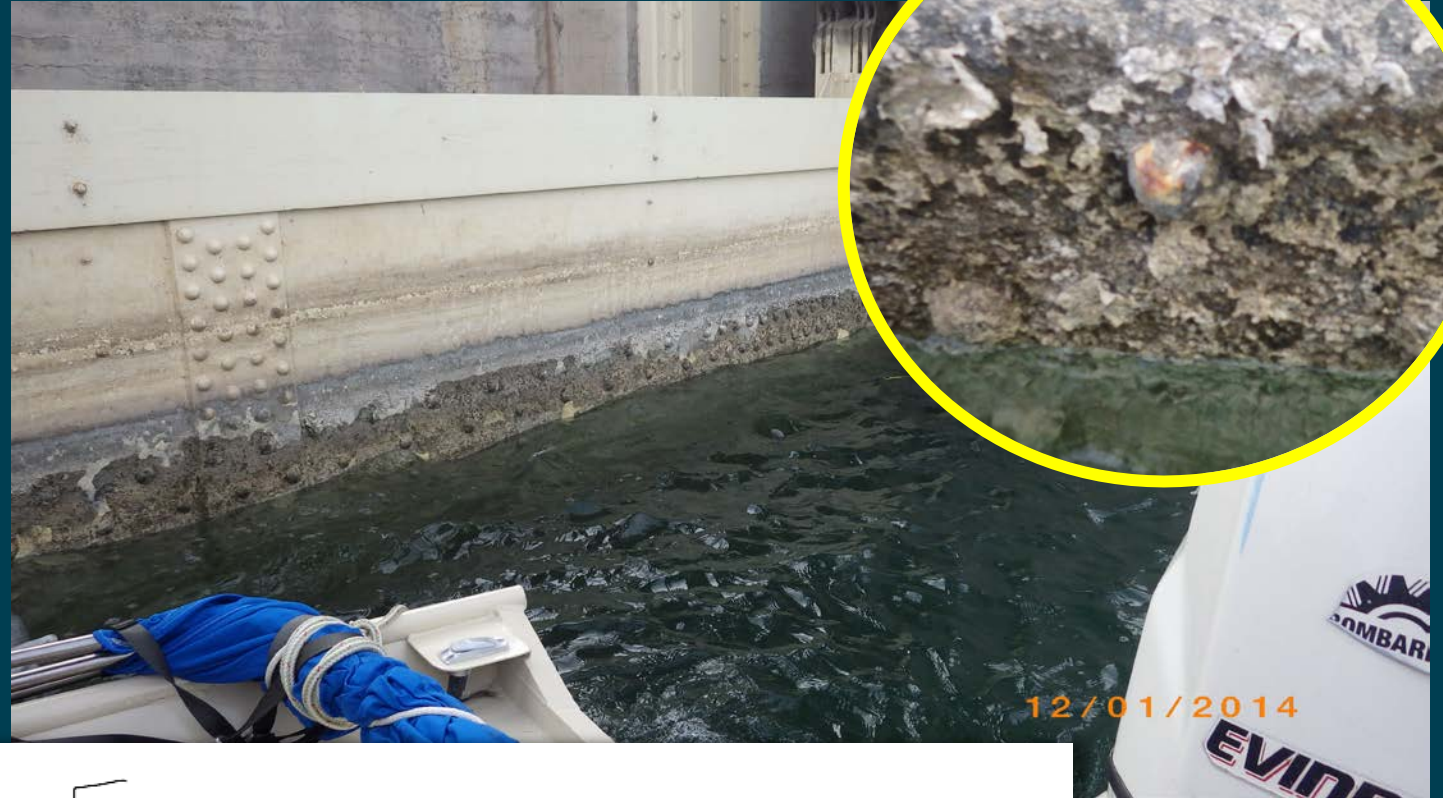
Design Data – Gate Inspection Dec 2014

Surface 0.418V vs C

5ft 0.410V

10ft 0.403V

20ft 0.398V

30ft 0.397V

Flow E → W (#1-5 E to W)
towards trashracks

Gate 5

more rusting
on rivets – maybe due to higher flow at this gate

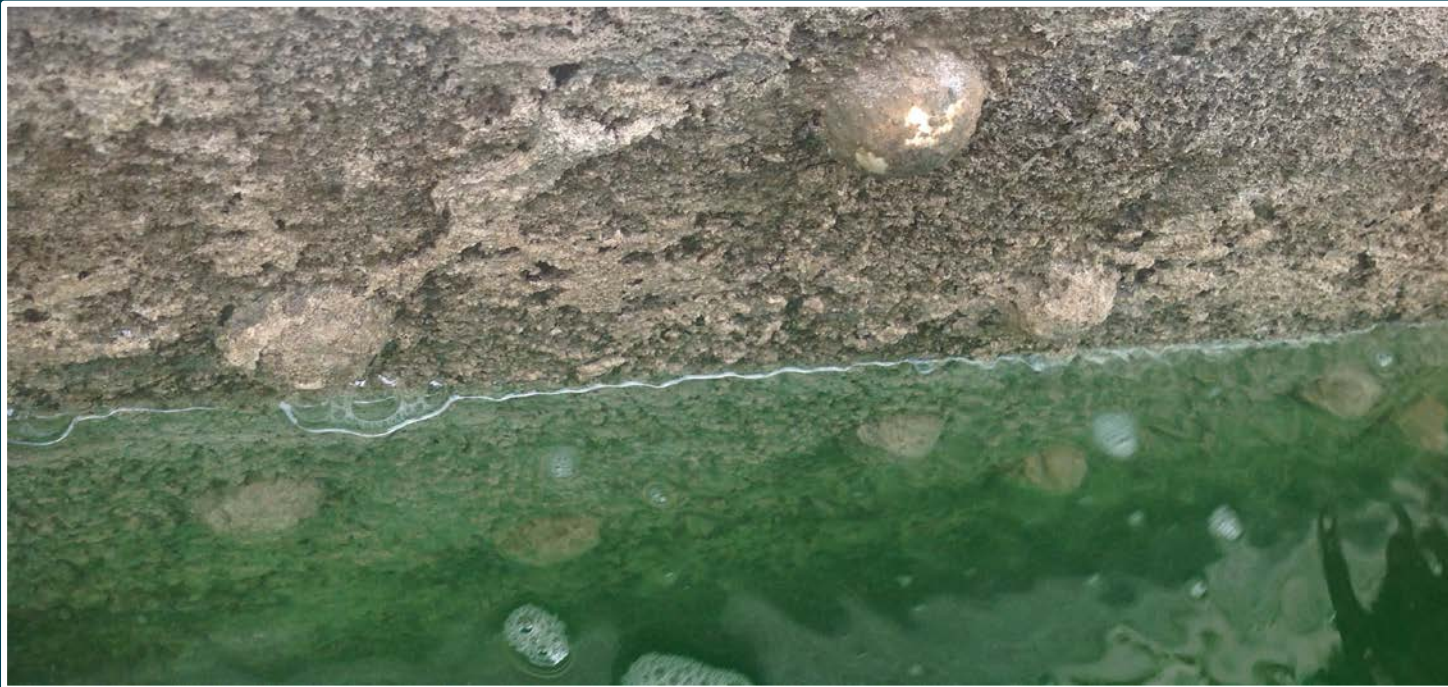
- Determine metal surface area
 - Each gate ~6600 rivets; add ~120 sq. ft. (~5%)

Component Name	SA (ft ²)	SA (m ²)
upstream skinplate	2500	232
rivets flat SA	175	16
rivets dome SA	298	28
skinplate minus rivet flat	2325	216
skinplate w/ dome rivets	2622.5	243.6

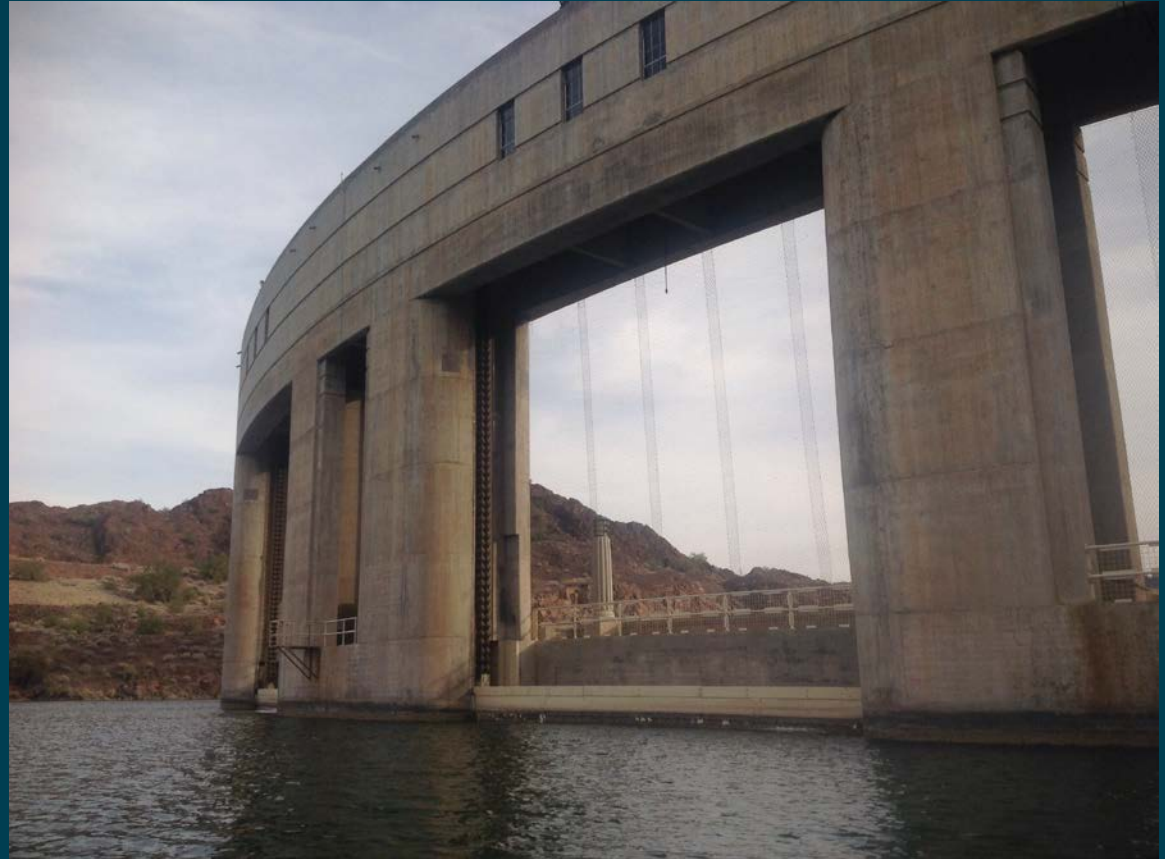
Anode mounting design

- Feasibility:
Anodes hanging from
suspended wire system
- Final:
Slotted PVC mounted to
concrete piers

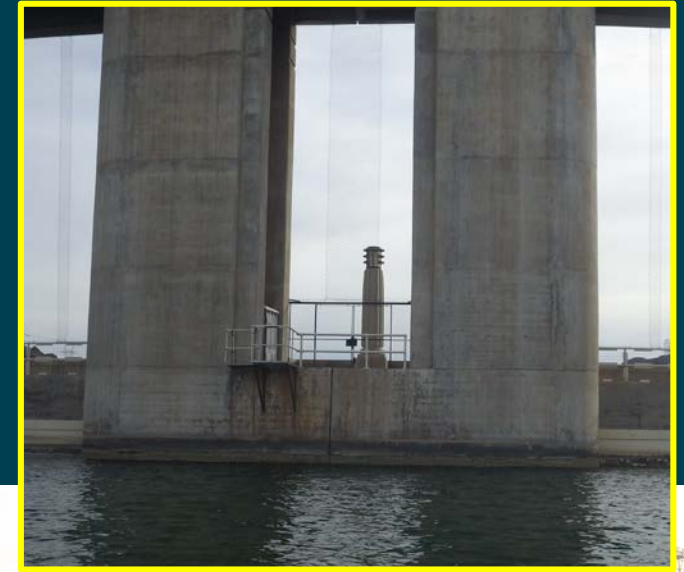
- Conduit size & path – diam. based on # of cables

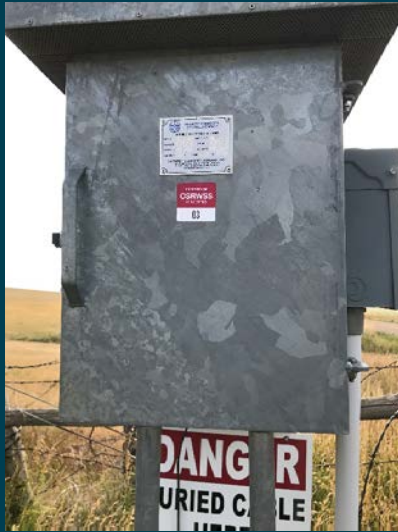
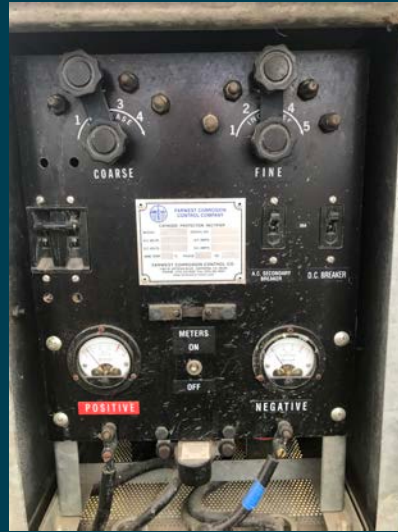
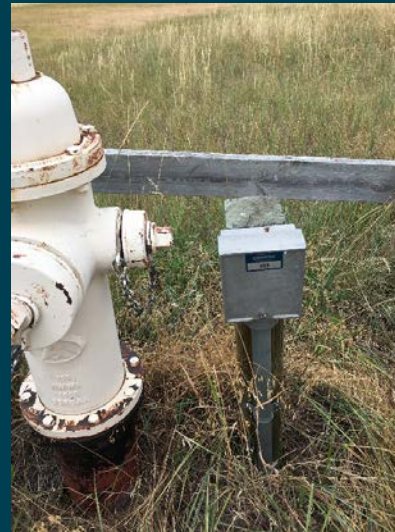
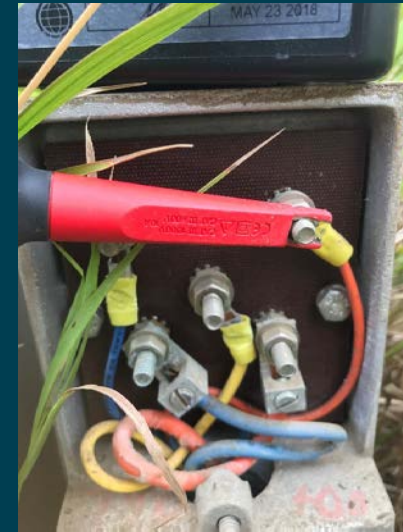
Rectifier

Test Stations

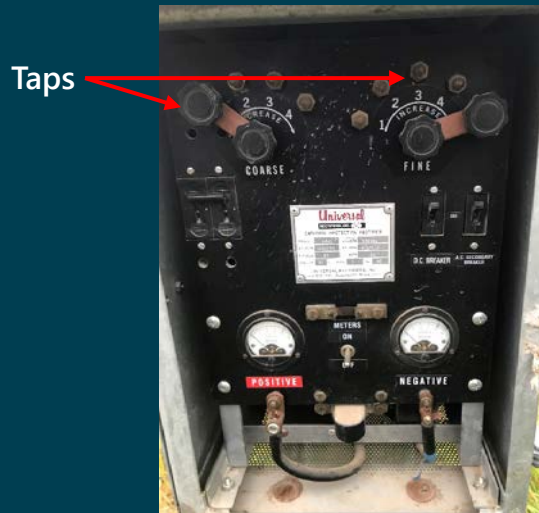
Voltage meter

- Data collected during the survey is crucial to determine the efficiency of a system.
- Rectifier Data needs include:
 - Condition (broken wires, vegetation overgrowth, insect infestation)
 - Rectifier information (rating, model, style, etc.)
 - Tap settings
 - Voltage output using meters and portable voltmeter
 - Current output using meters and portable voltmeter
 - Current output of anodes using portable voltmeter if possible

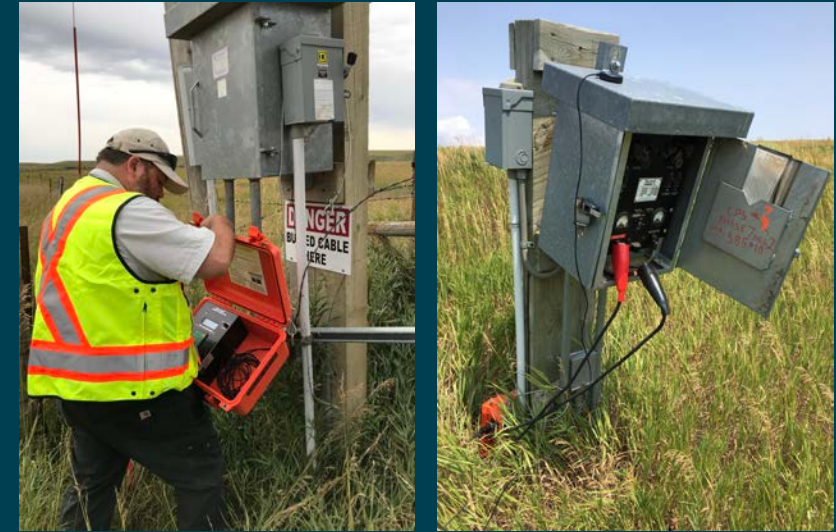
Current Interrupter Installation

- To perform the survey the system must be interrupted briefly. This can be performed in the following manner:
 - Disconnecting the anode cable from the structure cable at the shunt for GACP systems.
 - Installing an interrupter in the output circuit of a rectifier for ICCP systems.
- Typical interruption cycle is 7 seconds on and 3 seconds off.
 - Newer data loggers can measure a faster interruption cycle.
 - It is critical to interrupt rectifiers at the same time for systems with multiple rectifiers.
- A previous webinar was given on how to test a cathodic protection system and is available.

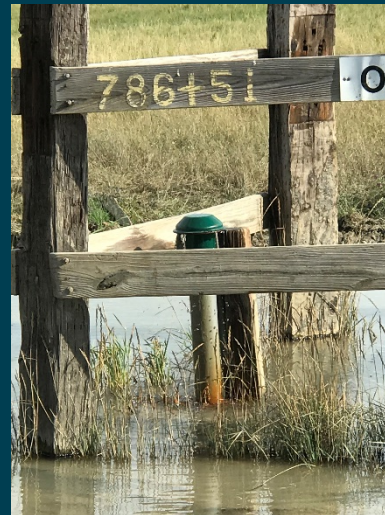
Inaccessible due to flooding
